REMEDIAL SAFETY TREATMENT OF ACCIDENT-PRONE LOCATIONS

Martha Leni Siregar^{1*}, Tuti Alawiyah¹, Tri Tjahjono¹

This study is aimed at finding the appropriate remedial safety treatment to improve the accident-prone sections at Gringsing Roundabout.

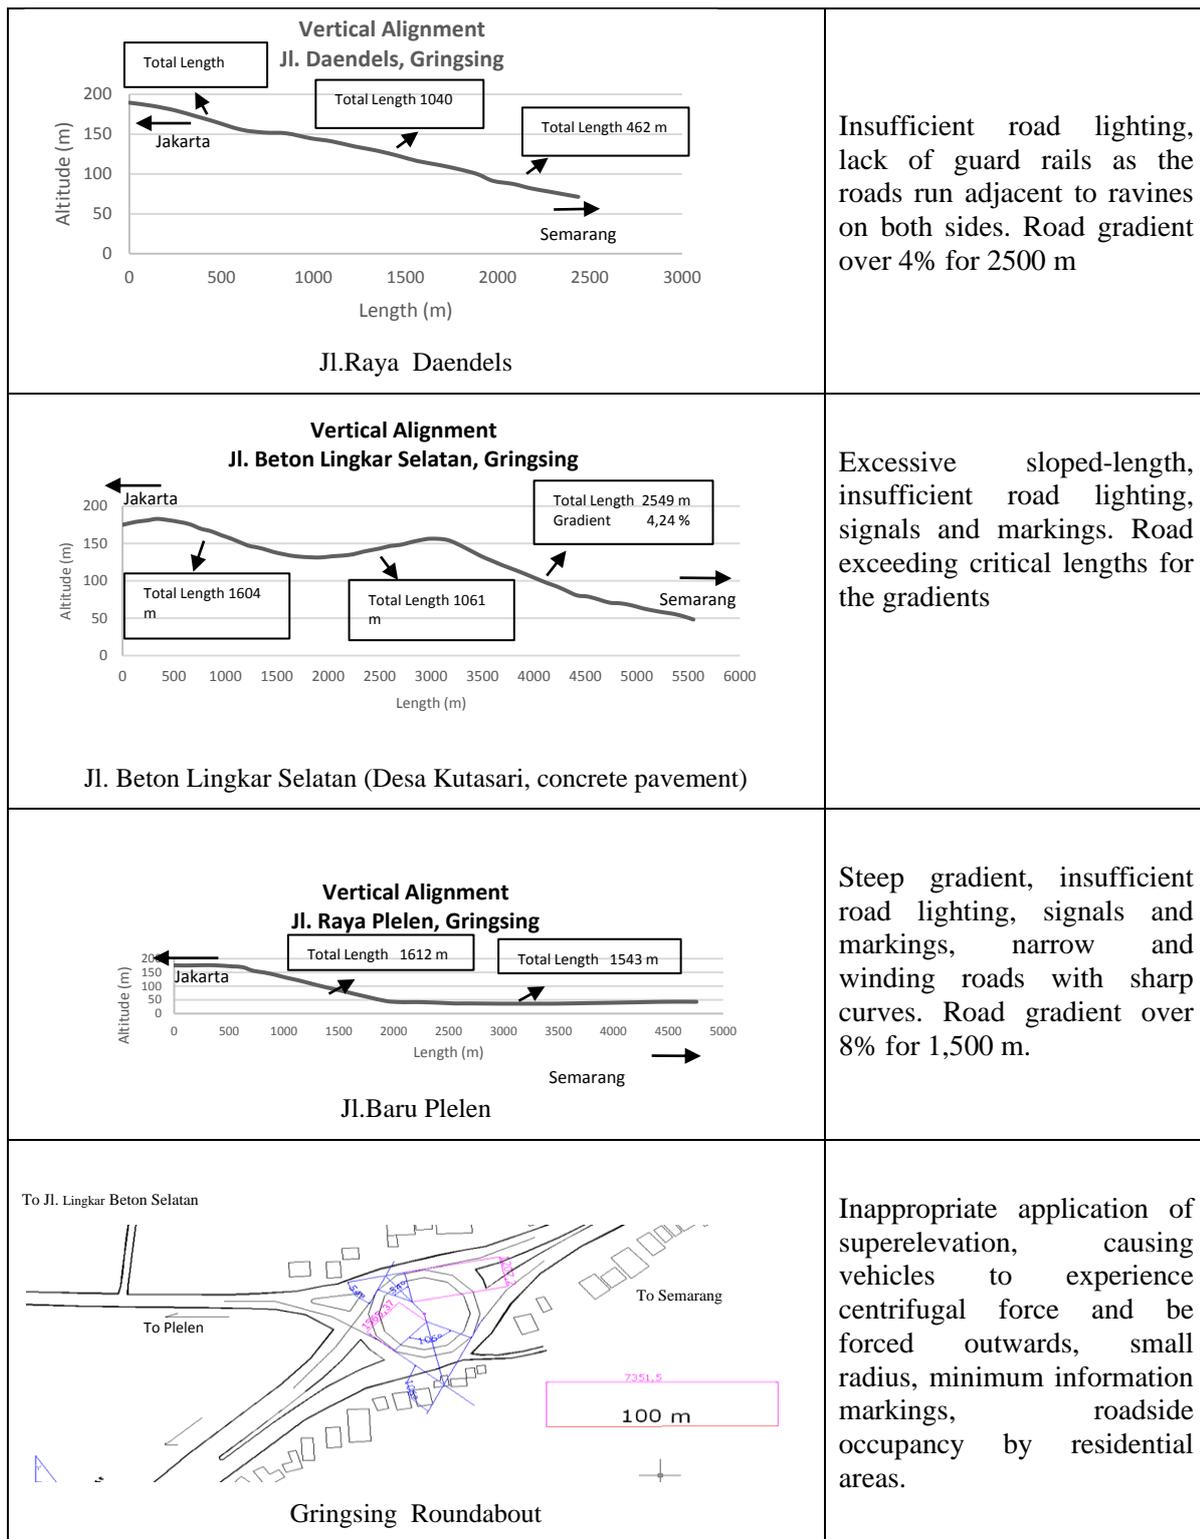
Figure 6 Analysis of geometric features

Direct measurement and on-site survey of the road conditions indicated that the vertical alignment exceeds the road geometry standard regulated by Bina Marga. Based on Figure 6 the average range of slope is between 2% to 5%, which actually does not exceed the allowable gradient of vertical alignment based on *Tata Cara Perencanaan Geometrik Antar Kota, 1997*. The road section with a 5% gradient, however, spans a length of 2,549 m which exceeds the maximum 210 m length for the gradient. This section forces drivers to press the brakes more often when they are travelling downhill, which may then cause early damage of the vehicles' braking system. This is in line with an earlier study that shows different gradients result in different levels of vehicle performance (Khan, et.al.,1990).

Long heavy vehicles are the category of vehicles which are mostly influenced by this sort of road condition as statistically confirmed by the accident data reports from the police. The plan view (horizontal alignment) of Jl. Beton Lingkar Selatan shows multiple compound short curves with relatively short tangents along a long vertical profile (2.549 m in length with 4.24% gradient). The plan and profile of the road segment are not harmoniously designed, which may

reduce drivers' anticipation capacity due to heavy driving task and may result in reduced level of alertness. Jl. Beton Lingkar Selatan leads to the 3-legged Gringsing Roundabout at the end of the section, which, based on the accident data, is one of the blackspots that needs to be analyzed.

As the length of the slope exceeds the critical length, climbing lanes need to be provided on the uphill gradient road and escape ramps need to be provided on the downhill gradient road. Based on the vertical alignment profile, a climbing lane is provided along Jl. Beton Lingkar Selatan to accommodate heavy vehicles climbing along the 4.24% uphill gradient of the 2,549 m of road section in the direction of Jakarta. The principal factor in determining the need for an emergency escape ramp should be the safety of the other vehicles on the roadway, the drivers of the out-of-control vehicles, and the residents along and at the bottom of the grade.

The relatively long downhill section of Jl. Beton Lingkar Selatan needs to be provided with an escape ramp for the vehicles facing braking system failure. The provision of an escape ramp is required in particular when vehicles lose control, machine overheating occurs or other types of mechanical problems, become a hazard to other vehicles and the need to pull out of the road traffic occurs in order to prevent accidents.

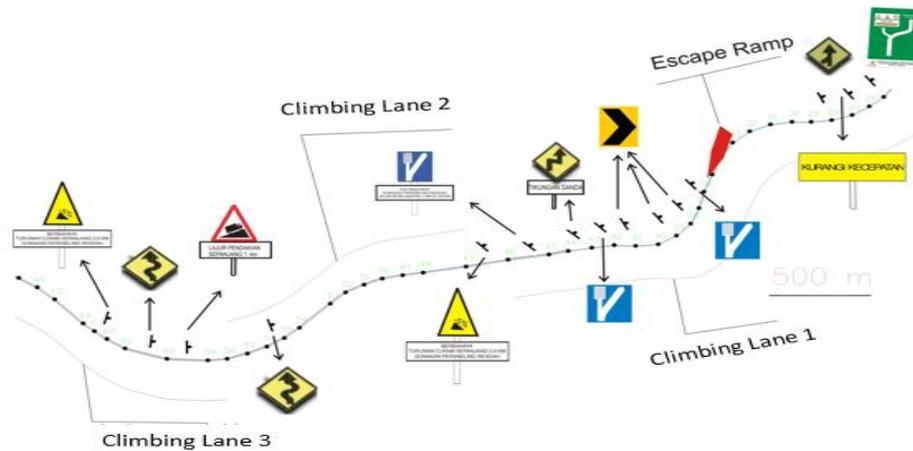
Figure 7 Proposed changes to the road geometry and signage

As clear markings and signs are of paramount importance in roundabout operations, inadequacy of information provided by unclear or missing information due to inappropriate location of signs and/or erased markings will lead to decreased quality of safety in the intersection. (Bahar et al., 2009; Cairney, 2000). Pavement markings, signs and signals are designed to move traffic safely, rapidly and efficiently. At Gringsing Roundabout, missing signs and markings profoundly dominate the conditions, which are worsened by inadequate lighting and supporting safety facilities such as guard rails, reduced sight distance due to obstructions from trees, plants, and buildings.

Witheyford (1992) developed a synthesis of highway practice on truck escape ramps and noted that the location and siting of truck escape ramps still pose problems as no universally applicable answers have been found. An escape ramp should be located wherever grades are of a steepness and length that present a substantial risk of runaway trucks and where topographic conditions will permit construction. Figure 7 shows the proposed changes to road geometry based on the *Panduan Penempatan Fasilitas dan Perlengkapan Jalan* (2006).

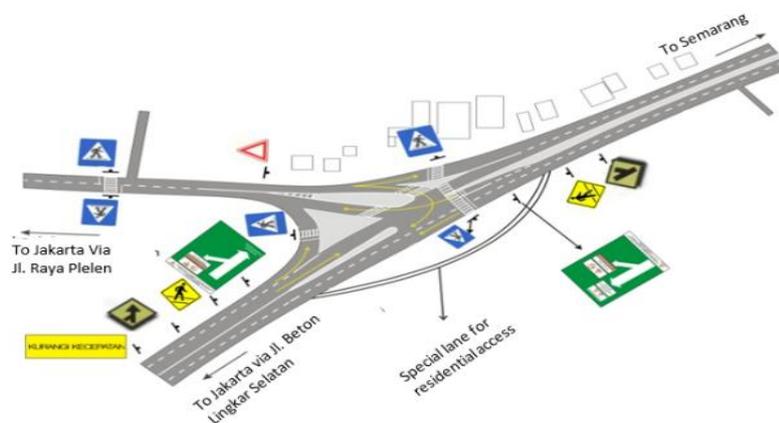
Figure 8 Proposed change of Gringsing Roundabout to a Y-junction and lay-out plan of road markings and signage

Regarding the dimensions, a further analysis on the roundabout geometric features was carried out and results indicated that the intersection radius is smaller than that of the minimum standard of radius. One of possible options is to recommend the minimum and followed by major physical changes to provide more turning space by widening the roundabout.

(Cerezo, 2010). As the roundabout under study is inconveniently located right at the end of a vertical alignment with a relatively large gradient which is suspected to be one of the main accident causations, truck drivers may have difficulties to adjust to the circulating maneuvers required along the roundabout. Ideally, steep downhill *gradients* should be avoided at maximum *roundabout approaches* or flattened to 2% before entry. The approach to the Gringsing Roundabout from Jl. Beton Lingkar Selatan (Desa Kutasari, concrete pavement) has a slope of 4.24%, much higher than the maximum 2% allowable gradient. The Highway Safety Manual (AASHTO, 2010) lists a catalog of Crash Modification Factors (CMF) for a variety of facility types, which provide guidance on the effect of grades on the expected roadway guidance safety measures (See Table 1). The base condition for grade is generally level. The Crash Modification Factor (CMF) is a measure of the safety effectiveness of a particular treatment or design element.

However, reducing the grade to a level grade is a costly alternative and therefore a possibility of changing the type of intersection is reviewed to check whether a simpler type could be adopted. Roundabouts are built so that road users cannot drive a straight path through the junction; instead, they have to drive round a traffic island located in the middle of the junction. This reduces speed (Elvik, 2004). Brake system failures experienced by drivers when approaching Gringsing Roundabout gives little possibility for drivers to reduce speed on the given length of road, thus indicating the need for a more simple type of junction to accommodate the deficiency of the road gradient. It is not always possible to improve a steep gradient by rebuilding the road. Based on AASHTO 2004 standards, it is indicated that instead of a roundabout, a minor/major priority type of junction, as a more familiar type, will still be sufficient and can be adopted. A 3-legged channelized priority junction is proposed with Jl. Beton Lingkar Selatan to serve as the major road leading in the direction of Semarang, and Jl. Pelen as the minor road. With the 3-legged type of intersection (Y-intersection) Jl. Beton Lingkar Selatan would serve as the major road leading to the direction of Semarang. It is therefore proposed that a new traffic management at the intersection is to be applied, thus allowing traffic from the major road to be prioritized with the provision of a 'Give Way' sign at the Jl. Pelen leg, as the minor road. The proposed change of type and markings at and around Gringsing intersection would be based on the Guidance for Road Facilities and Utilities as shown in Figure 8.
