## Evaluation of Reuse and Recycling Disaster Waste Materials for Post-disaster Shelter with Compressive Strength Testing and Case Study in Cianjur, Indonesia

**Abstract.** Earthquake activity in Indonesia increases annually, causing more victims to require shelter and a rise in disaster waste. This waste can pose health risks and safety threats to humans, making careful management essential. One way to address this issue is recycling or reusing disaster waste materials to construct shelter. Therefore, this study aimed to investigate the performance of earthquake waste materials, recycled or reused as post-disaster shelter. To achieve this objective, a case study was conducted in Cianjur, Indonesia, where a recent earthquake occurred, and waste material samples (red brick, ceramic tile and roof tile) were collected for testing. Moreover, the compressive strength of the materials was measured in comparison with new building materials. The results shows that ceramic tile and roof tiles meet the compressive strength standards and can be reuse for post-disaster shelters, with compressive strengths of 17.7 MPa and 21.8 MPa.

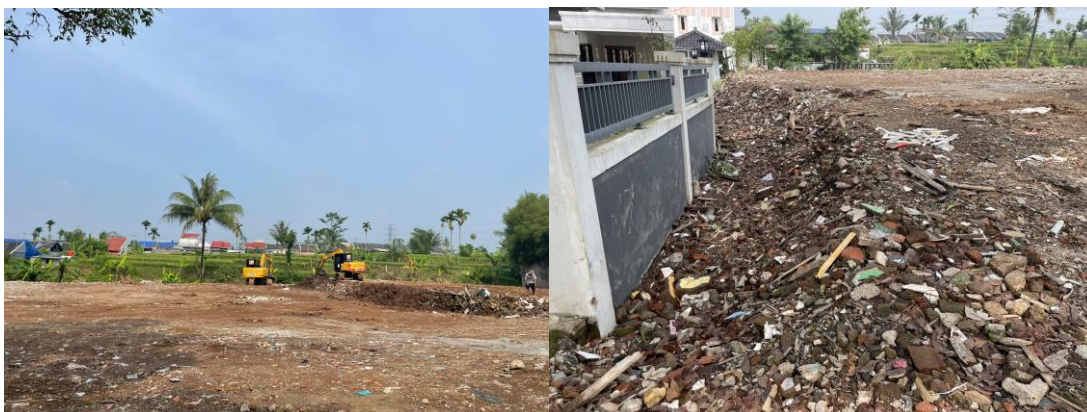
**Figure 2** Landfill for disposing disaster waste

The case study location was the earthquake epicenter in Cianjur, specifically Sarampad Village, Cugenang District, Cianjur Regency, West Java. This region was highly earthquake-prone, with an MMI scale greater than VIII, showing the potential for ground cracks, slope movement, and land shifts (PVMBG, 2014). The earthquake occurred on November 21, 2022, with a magnitude of 5.6 and a damage intensity of VIII on MMI scale (Putratama, 2022). After a year of recovery, various facilities were constructed in the affected area. This site currently includes a nearby post and a 3,546.82 m<sup>2</sup> landfill designated for disaster waste disposal (Figure 2). Other facilities, such as schools and mosques, had also been established. The earthquake caused significant damage and loss of life. According to (Asmarini, 2022), 268 people died, 1,083 were injured, and 58,362 were displaced due to structural damage. Moreover, the destruction spanned three regions and sub districts, with 21,282 houses damaged, including 6,570 suffering severe destruction. To aid disaster victims, several shelters, mosque facilities, and schools have been rebuilt. Recycle House Program (RHP), led by Mr. Sunaryo Adhiatmoko, was selected as the focus of this case study. The program conceptualized house reconstruction post-earthquake using recycled materials (Figure 3).

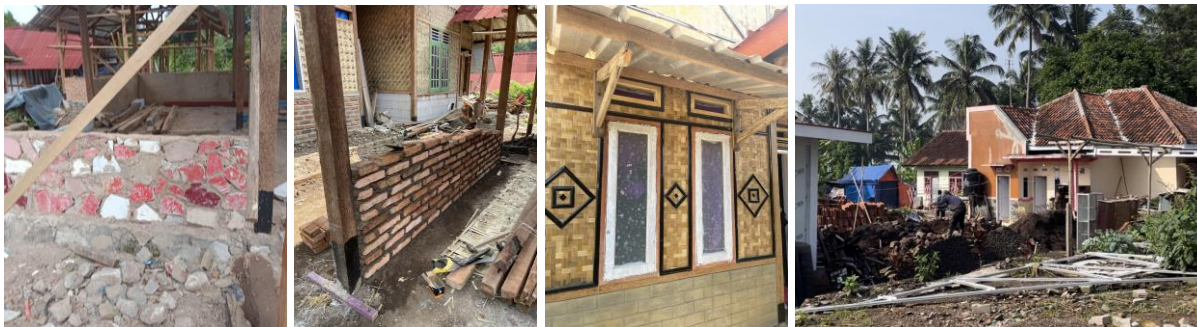
**Figure 5** Application of Disaster Waste Material in Recycle House Program and Residents Houses

Table 2 provides an overview of disaster waste materials that can be repurposed for shelter based on case study and theoretical investigations. Meanwhile, Figure 5 presents the practical application of these materials in RHP case study. Examples include mixed ceramic shards and bricks used for walls, repurposed wooden window and door frames, and reused roof tiles. Based on the types of materials identified at the site, specific waste materials were selected for testing. The selection process considered the application in RHP, use in residents' houses incorporating disaster waste, the availability of comparative materials, and the accessibility of testing equipment. The selected materials for testing included red bricks, roof tiles, and ceramic tiles.

RHP had constructed 352 units in the disaster-affected area. These structures used coconut wood sourced from West Sumatra, bamboo walls made by craftsmen, spandex roofs, GRC list planks, and brick walls (Figure 4). Disaster waste materials, such as wood and concrete shards, were also repurposed for doors, window frames, brick walls, and foundations. In total, 3,546.82 m<sup>2</sup> of disaster waste was collected in an open field, forming a pile approximately 1 meter high. This abundance of waste prompted the village community to reuse 50% of the discarded materials for home reconstruction. Table 2 and Figure 5 present the types of disaster waste materials found and utilized in the case study.

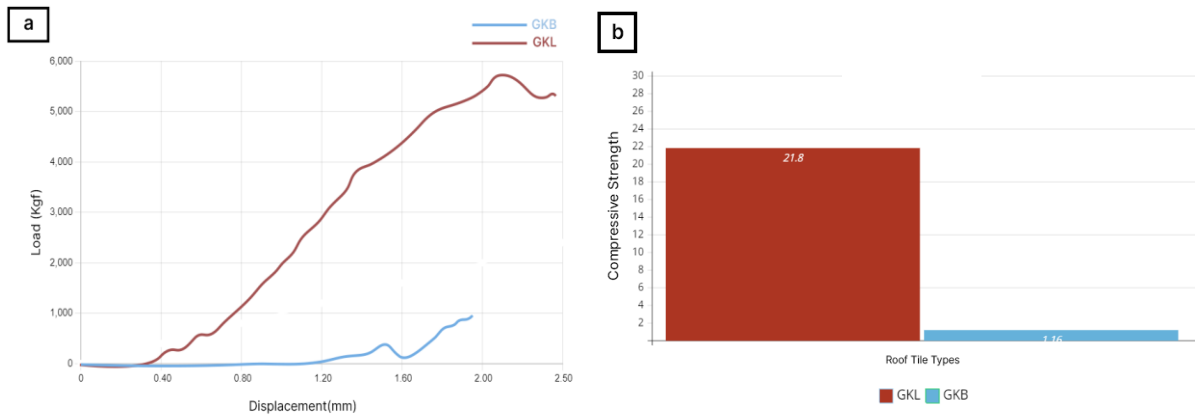
**Figure 8** GKL and GKB Compressive Test Results: Compressive stress–strain curve (a), Compressive strength value (b)

Figure 8(b) shows the compressive strength results for roof tiles, showing significant differences between samples. Roof tiles made from disaster waste materials (GKL) showed a compressive strength of 21.8 Mpa, much higher than that of new roof tiles (GKB) at 1.16 Mpa. This phenomenon could be attributed to load differences. Table 6 shows GKL with a load value of 55.809 N, significantly greater than GKB’s load, resulting in higher compressive strength for GKL. Figure 8(a) further explains this phenomenon, as GKB’s force curve was smaller and had a faster crack than GKL. However, the cause of the very different compressive strength values needs further investigated.

The test results were compared with the compressive strength standards, as shown in Tables 8, 9, and 10. The comparison showed that BML did not meet the standards outlined in (SNI-15-2094, 2000) and (ASTM C62, 2018), while BMB did. GKL satisfied the standards provided by (Akinwande et al., 2021) and (Rajalakshmi R., 2020) but GKB did not. KL did not meet the standards from (CES Edu Pack Software, 2013) but complied with (ASTM C 1424, 2019). Lastly, KB met the compressive strength standards specified in both references. Based on this analysis, disaster waste materials deemed suitable for shelter construction were KL and GKL. However, further investigation was required to address materials that did not meet the standards.
