GREEN MAINTENANCE FOR HERITAGE BUILDINGS: AN APPRAISAL APPROACH FOR ST PAUL'S CHURCH IN MELAKA, MALAYSIA

Brit Anak Kayan¹, Imaduddin Abdul Halim¹, Nurush Syhadah Mahmud^{1*}

¹*The Centre for Building, Construction & Tropical Architecture (BuCTA), Faculty of Built Environment, University of Malaya (UM), 50603 Kuala Lumpur, Malaysia*

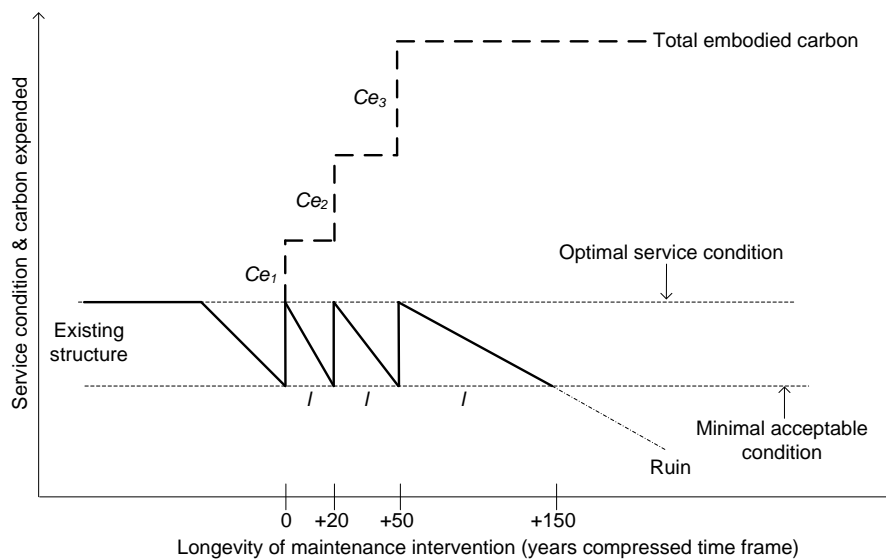
Figure 2 Relationship between longevity of repair and embodied carbon expenditure (Source: Kayan, 2013)

The downward slope signifies a declining condition over the life cycle of repair. Each intervention is important toward keeping the building at optimal service condition. Hypothetically, the more frequent the maintenance intervention, the greater the amount of embodied carbon expended (Forster et al., 2011). Thus, Green Maintenance places preference on repair techniques that have high longevity, which subsequently results in fewer interventions

By addressing the relationship between CO₂ emissions and maintenance and repair, the Green Maintenance methodology provides some insight into the selection of low-carbon repair techniques for heritage buildings. To understand the relationship between each intervention, they are characterized by their longevity (*l*) and embodied carbon expenditure (*C_e*), as shown on the service graph (see Figure 2; Kayan et al., 2017).

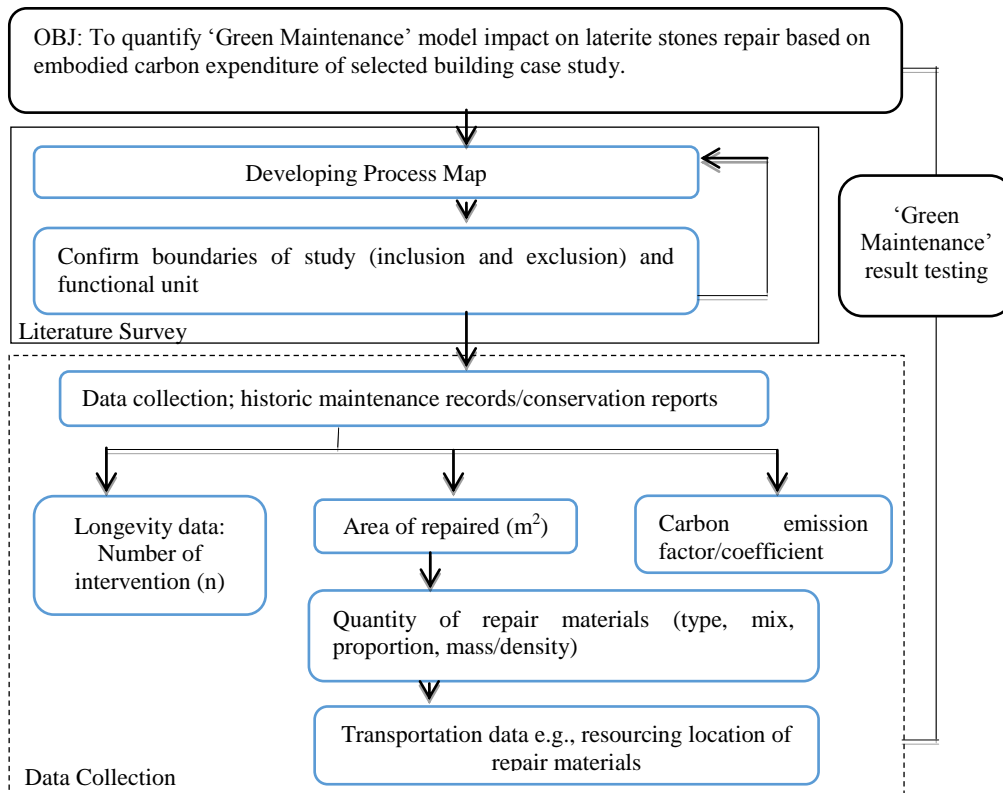
Figure 3 Research flow

To test the Green Maintenance model, the present study adopts a quantitative mixed-methods approach, whereas the case study was mainly used to collect data on maintenance (i.e., conservation reports and interviews). To quantify the CO₂ emissions from the repair of St. Paul’s Church, several steps needed to be followed, as illustrated in Figure 3.

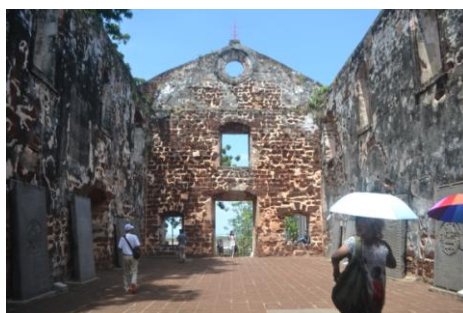
Figure 5 Exposed interior of St. Paul's Church, Melaka, Malaysia

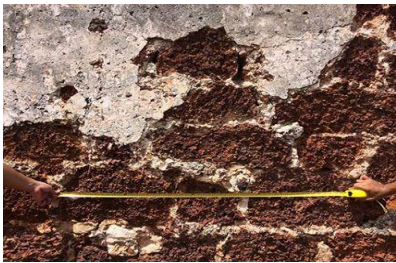
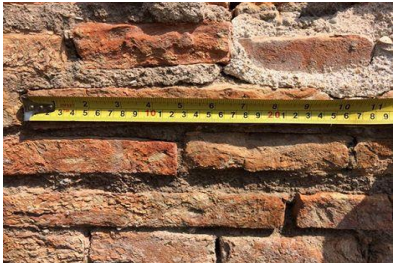
Table 1 Construction material of St Paul's Church

Type of Stone	Laterite Stone	Dutch Brick

Total Wall Surface	603.52m ²	13m ²
No. of Stone Blocks Used	2,736 blocks	1,300 blocks
Size of Stone (mm/block)	700mm×300mm×300mm	215mm×125mm×40mm
Mass of Stone (t/block)	±0.1 t/block	±0.002 t/block

Table 1 summarizes the profile of laterite stones used in the external wall of St. Paul's Church, which was generated from site surveys and mathematical calculations. It is believed that the laterite stones were locally sourced from Ilha das Pedros (Pulau Upeh, Melaka, Malaysia) and Cape Ricardo (Port Dickson, Negeri Sembilan, Malaysia), as evidence of laterite cuttings can be seen across the island and surrounding areas, as well as from materials salvaged from other buildings built by the Portuguese and the Dutch (Khou, 1997). However, there are no active stone quarries within the area at present (Zulasmin & Ibrahim, 2007).

When considering stone replacement, an issue arises concerning the scarcity of laterite stone. As shown in Table 1, brick has been used to replace the deteriorated laterite in many areas, sparking a philosophical debate over the use of like-for-like materials and honesty as the pillars of Malaysian society. This creates demand for expert perspectives on the "trade-off" between the loss of historical materials and the reduction of CO₂ emissions (Forster, 2010). When they are initially applied, repairs can clearly be seen; however, the blurring of the old and new materials may occur as patination develops. If like-for-like repair strategies are selected, the use of salvaged material is proposed to reduce CO₂ emissions generated during the transportation phase. In another case study, conducted by Azizul (2015), it was revealed that the laterite stone used in the reconstruction of the Bastion Middleburg, imported from Prachinburi in Thailand (1,797 km), was one of the highest contributors to the CO₂ emissions generated from that project. It was also found that the use of salvaged material is not as easily incorporated in building practices that typically require locating the source early and planning from the start of a dilapidation survey. In this case, Kayan et al. (2018) suggested that significant efforts should be made toward reopening the old quarries, known as snatch quarrying, which would entail a

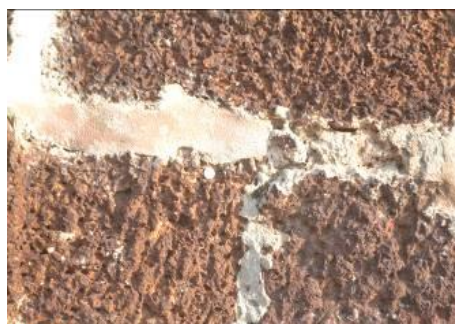
Figure 6 Modern mortar for the pointing of St. Paul's Church

Lime-based mortar is the most common building material found in the bedding, pointing, and finishing of many heritage buildings, including St. Paul's Church (Mydin, 2017); however, there is no exact ratio for the mortar mixes recorded in any of the building's maintenance documents. To achieve the aims of the present study, Khou's (1997) observations are taken as a reference, who distinguished between two cross-cutting generations of concrete and mortar. The earlier mortar mix is composed of lime and sand; a thin layer of smooth, rounded laterite pebbles; and some other material (e.g., coral, angular pieces of charcoal, or exfoliating oyster shells). The later mortar shows better workmanship to an extent, as its sand matrix is more evenly sorted, containing coarse granules but not the fine granules found in the earlier mortar. However, the original structure was also cemented in modern mortar (see Figure 6), which obscures the earlier and later mixes.

To quantify these mixes, the earlier mortar is comprised of a 1:3 ratio of limestone and sand, while the later mortar contains a 1:1:2 ratio of limestone, brick dust, and sand (Matias et al., 2016). "Modern mortar" refers to a lime-based material used by the Bastion Middleburg, which, according to guidelines underlined in its reconstruction, is constructed from a 1:1:3 ratio of

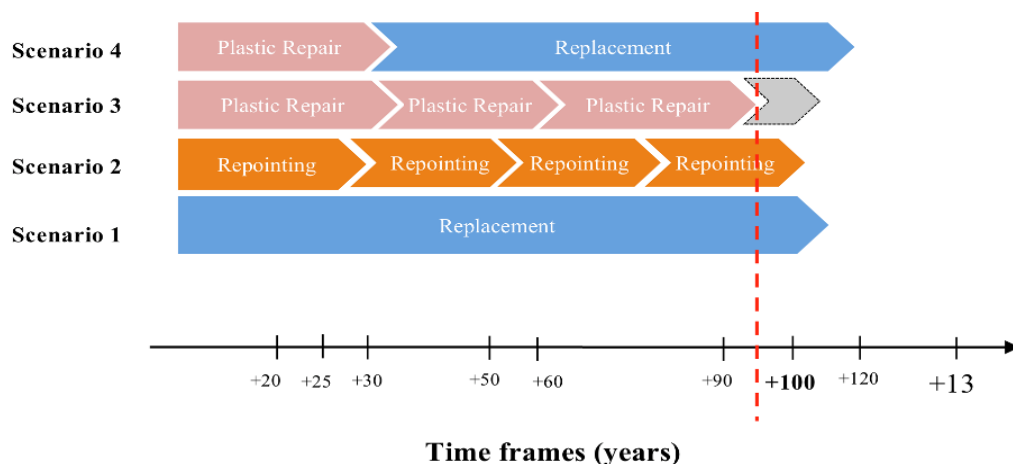
Figure 7 Repair scenario and timeframe (adapted from Forster et al., 2011)

There are four common repair techniques in the maintenance of heritage buildings, known as stone replacement, plastic repair, repointing and pinning, and consolidation, which are selected according to their relative levels of intrusion on the original material. There are several repair options (i.e., scenarios) that may be beneficial in merging the technical and philosophical aspects of masonry conservation. For example, the repeated repointing of deteriorated mortar joints would have a limited effect on the adjacent laterite structure. In contrast, the removal of deteriorated laterite stone and replacement with new stone blocks logically requires the removal of greater quantities of the original material. It must be noted that certain combinations of laterite stone repair techniques are more common than others. Stone replacement could be practically done only once, while plastic repair is commonly followed by natural stone replacement within a given maintenance period. Conversely, it would be highly unusual to replace the stone and then conduct a plastic repair intervention within the same period (Kayan, 2013). From an extensive examination of the collaborative partners that are responsible for the upkeep of St. Paul’s Church, such as the Melaka Museums Corporation and the Malaysian Department of National Heritage, both of which verified the results, there were three repair techniques found to be modeled on the building’s EMI over the last 100 years (Forster et al., 2011). The laterite stone structure of St. Paul’s Church has lasted for more than 500 years and is still in good condition; thus, to estimate the best technique for longevity, an average maintenance period of 100 years is used in the present study. Figure 7 defines four scenarios for the maintenance of a laterite stone structure over this period.

laterite stones (see Figure 8). The material life expectancy of 100 years may lead to fewer maintenance interventions in the study period (see Scenario 1 in Figure 7).

under study. In practice, however, the plastic repair technique requires supplementary techniques and/or interventions (e.g., stone replacement) due to its low longevity of repair, as illustrated in Scenario 4 (see Figure 7), which results in a relatively high amount of CO₂ emissions (177 kgCO₂e/t/m²) over a period of 100 years. Additionally, based on the total generated EMI in Figure 11, the results reveal that repeated repointing contributed 152.402 kgCO₂e/t/m², although Table 3 shows a low initial embodied carbon expenditure per functional unit in 1 m² (0.28 kgCO₂e/t/m²) compared to other scenarios and techniques. In this case, it is important to consider the repair strategies that are most suitable for dealing with the particular area of deterioration. For example, the quantity of repair materials required for repointing highly depends on the thickness and depth of the original pointing. The thicker and deeper the pointing (in this case, between 50–100mm), the more lime mortar needed (kg). Considering the large area of deterioration and high rate of exposure of buildings such as St. Paul's Church, this could significantly impact the embodied carbon expenditure. In plastic repair, the quantity of lime mortar can also be viewed in terms of the different mixtures required to match the façade, which depend on the depth, undercoat, topcoat, and thickness of the patch. In this case, lime mortar is not cost effective in the long term when dealing with a large area of deterioration. Instead, white cement is used in several interventions, as it is cheaper and more readily available than lime-based materials; however, it is technically incompatible with the original material and will thus limit the longevity. Clearly, the selection of low-carbon repair materials should not only consider the single value of embodied carbon expenditure but also the durability.

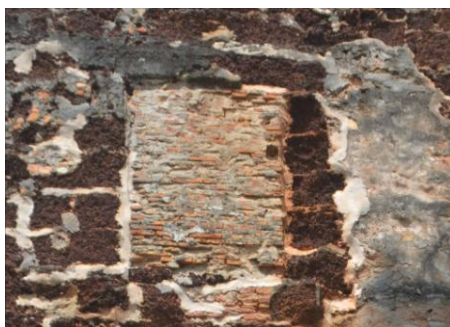
Figure 8 Bricks for stone replacement

Stone replacement is a repair technique that involves seriously decayed stonework, in which the decayed stone is dug out then replaced with a newer matching one (Hyslop, 2004). In the case of St. Paul’s Church, it was found that bricks were sometimes used to replace the original

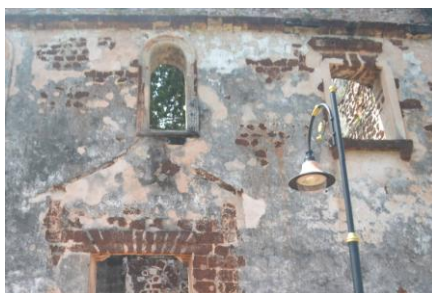
Figure 9 Mortar patching over the laterite wall surface

Plastic repair, also known as mortar repair, involves seriously decayed stonework as well, but it only affects the surface area (Dime & Ashurt, 1998). Typically, the decayed stone must be cut back, then lime-based mortars are applied to the surface (Hyslop, 2004). In the present case, this technique is limited to plastering and patching (see Figure 9). The effects of this technique generally lasts for only 30 years and thus must be periodically reapplied (see Scenario 3 in Figure 7; Forster et al., 2011; Kayan, 2013). In some cases, such as in Scenario 4, the decayed stone may not withstand repeated plastic repair and thus must be replaced with new stone.

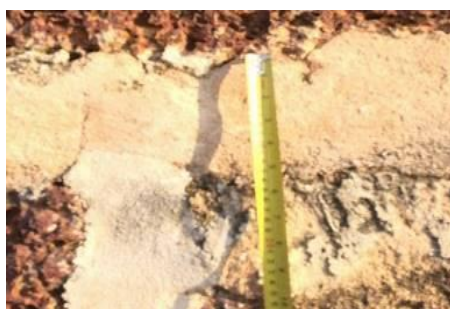
Figure 10 Repointing technique used on St. Paul's Church (50–100mm thick)

Repointing is the most common technique for the repair of loose, open, crumbly, and/or washed-out bedding and jointing mortar in a wall (see Figure 10; Dore et al., 2013).

Normally, the mixture consists of binders and sand, which is available in a pre-mixed package. To repair defects and decay, repointing involves the removal of the failed jointing mortar (to a depth of at least $\frac{3}{4}$ inch) and applying new mortar as a finishing to replicate the original mortar

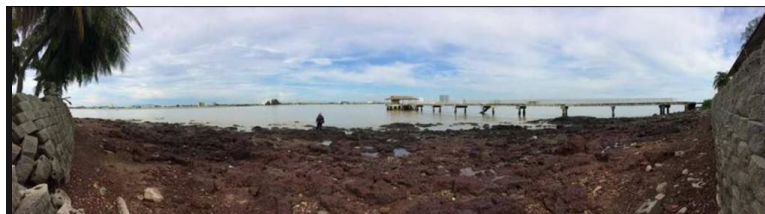
Figure 12 Old laterite stone quarry at Pulau Upeh, Melaka, Malaysia

temporary opening to obtain a limited supply of laterite stone, rather than using bricks with unknown durability. The large availability of laterite stone at an old quarry located in Pulau Upeh, Melaka, Malaysia (see Figure 12) could be optimized to ensure the feasibility and quality of future stone-replacement projects. As the Green Maintenance methodology has provided a base repair area of 1 m² when quantifying CO₂ emissions, the typical amount of laterite stone required to fill this area is around five blocks. Ideally, the process of extracting and quarrying laterite stone will not be the main cause of CO₂ emissions per se, as the embodied energy expenditure reported by Praseeda et al. (2014) was solely caused by the diesel-operated machinery used in the initial cutting process, either in soil or on a bed of laterite (0.0069 MJ/kg contributed for 1 block of laterite with the dimensions of 400×200×250 mm). Comparatively, if the process is handled manually, there will be zero impact on CO₂ emissions due to extraction and quarrying. Therefore, it is possible to significantly reduce the CO₂ emissions contributed by stone replacement.
